*Chapter Six:*  
**Park Inventory**

## Birchwood Park

# Candlewood Park

# Ganzhorn Park

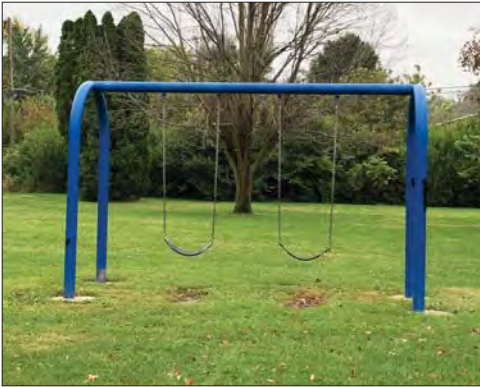
- The playground does not appear to be compliant with current playground safety guidelines and CPSC/ASTM standards. Proper play surfacing is not utilized beneath. Swing seats are not a recommended style and open "S" hooks create entanglement and impalement hazard.
- The park does not have security lighting.
- The park's street frontage allows for adequate surveillance.
- A park identification sign is present, however a park rules sign is absent.

Swings (2 belt)

- Remove existing play equipment.
- Provide small scale new play equipment with safety surfacing and accessible pathway to street.
- Provide additional buffer planting near adjacent residence.
- Thin understory species along Farm Creek to allow visibility.
- Update benches with picnic area as dictated by new site development.
- Refine accent planting adjacent to sign.

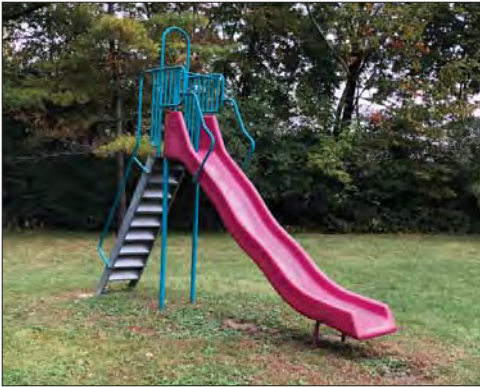
- The playground does not appear to be compliant with current playground safety guidelines and CPSC/ASTM standards. Proper play surfacing is not utilized beneath swings and slide. The playground is remotely located.
- The park does not have security lighting.
- The park's street frontage allows for adequate surveillance.
- A park identification sign is present, however a park rules sign is absent.

Slide

- Remove existing play equipment.
- Provide medium scale new play equipment with safety surfacing and accessible pathway to street. New location should be closer to the shelter
- Emphasize views from the park to the Cemetery Road Bridge (part of the National Historic Registry) adjacent to the park on Candlewood Road. Potential for overlook and interpretive signage in addition to brush clearing along tributary.
- Improve parking edge/lot

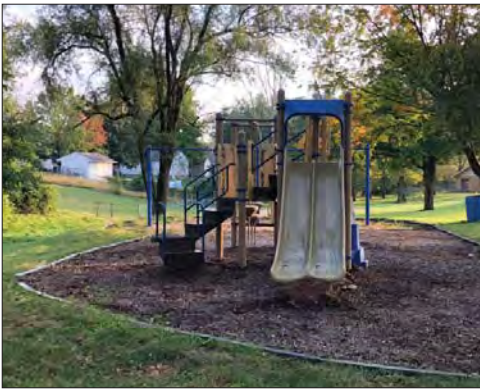
- The playground appears to be compliant with current playground safety guidelines and CPSC/ASTM standards.
- The park does not have security lighting.
- The park's street frontage allows for adequate surveillance.
- A new park identification sign is present, however a park rules sign is absent.

5-12 Play Structure and Swings (2 belt/2 tot)

- Repair/replace playground edging.
- Provide gathering area/seating adjacent to play area/basketball court.
- Provide an accessible route to each amenity.
- Re-surface and stripe the basketball court.
- Refine accent planting around and adjacent to sign.

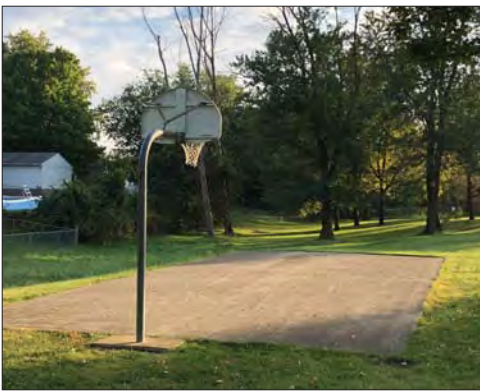
- The park has open areas for non-programmed use.
- Site furniture that can be found throughout the park include 1 trash receptacle.
- The playground has adequate separation from the roadway.
- The playground includes a 5-12 play structure, 2 belt/2 tot swings, plastic edge separation, and engineered wood fiber play surfacing. The playground edging is broken in several places and the play surfacing needs replenishment.
- A half basketball court with 1 new post/net is located next to the playground. The basketball court has several cracks/divots present and does not have any visible striping.
- The park is well maintained and free of litter.

Half Basketball Court

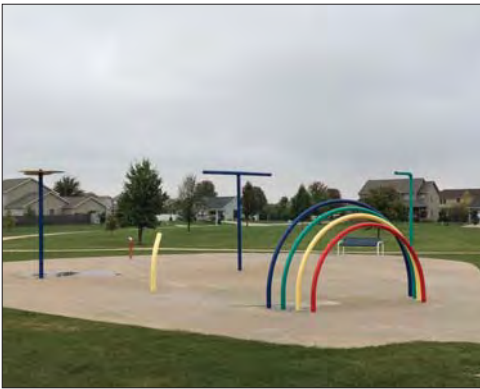
Splash Pad

- Add landscape layers.
- Add rules and regulations sign to 5-12 year old play structure.
- Consider adding more spray events/balanced with lower water use.
- Consider splash pad water recapture system for irrigation.

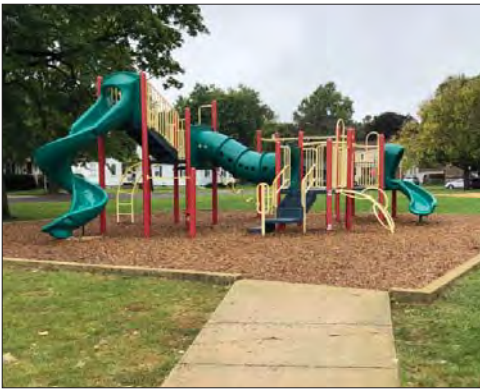
- The park does not have any internal walkways, however the adjacent walkways are connected to the neighborhood walk system.
- The playground equipment appears to meet most ADA accessibility requirements for play environments, but does not have an accessible entry into the play surfacing. The path connection from the parking lot to the playground also exceeds accessibility slope requirements.

5-12 Play Structure

- Install accessible ramp entry into play surfacing along the main walkway.
- Re-configure the path system to make a stronger, safer connection to the Administration Building.
- Repair parking lot.
- Address drainage/erosion issues around playground area.
- Improve barrier between parking lot and play environment.
- Consider picnic amenities like Bocce, Baggo, and Horseshoes with rentals managed in the Recreation Facility.

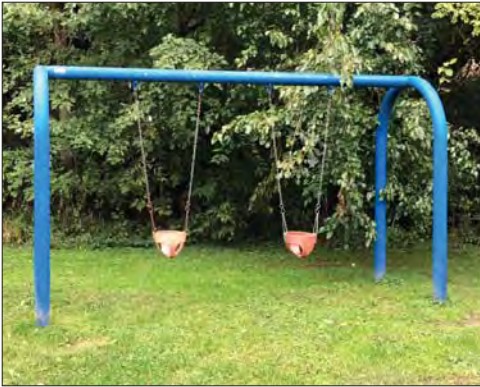
- The playground does not appear to be compliant with current playground safety guidelines and CPSC/ASTM standards. Proper play surfacing is not utilized beneath swings and slide. The swings are not a recommended frame style.
- The park does not have security lighting.
- The park's street frontage allows for minimal surveillance.
- A park identification sign and shelter rental sign are present, however a park rules sign is absent.

Swings (2 tot)

- Remove play equipment and replace with a small-scale play environment.
- Provide accessible route to picnic and play areas.
- Provide plant material to aid existing split-rail fencing to buffer residential edges.
- Thin understory vegetation along creek to provide visibility.
- Refine landscape accent at sign.
- Consider botanical garden features/theme with park development to accent tree collection.

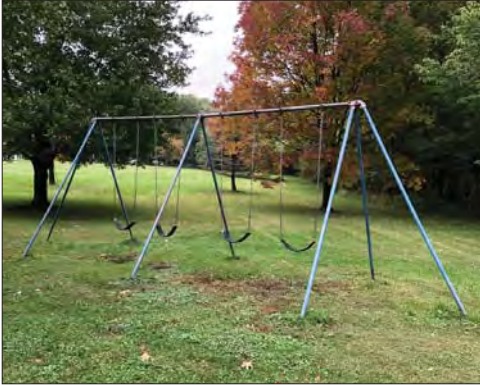
Swings (4 belt)

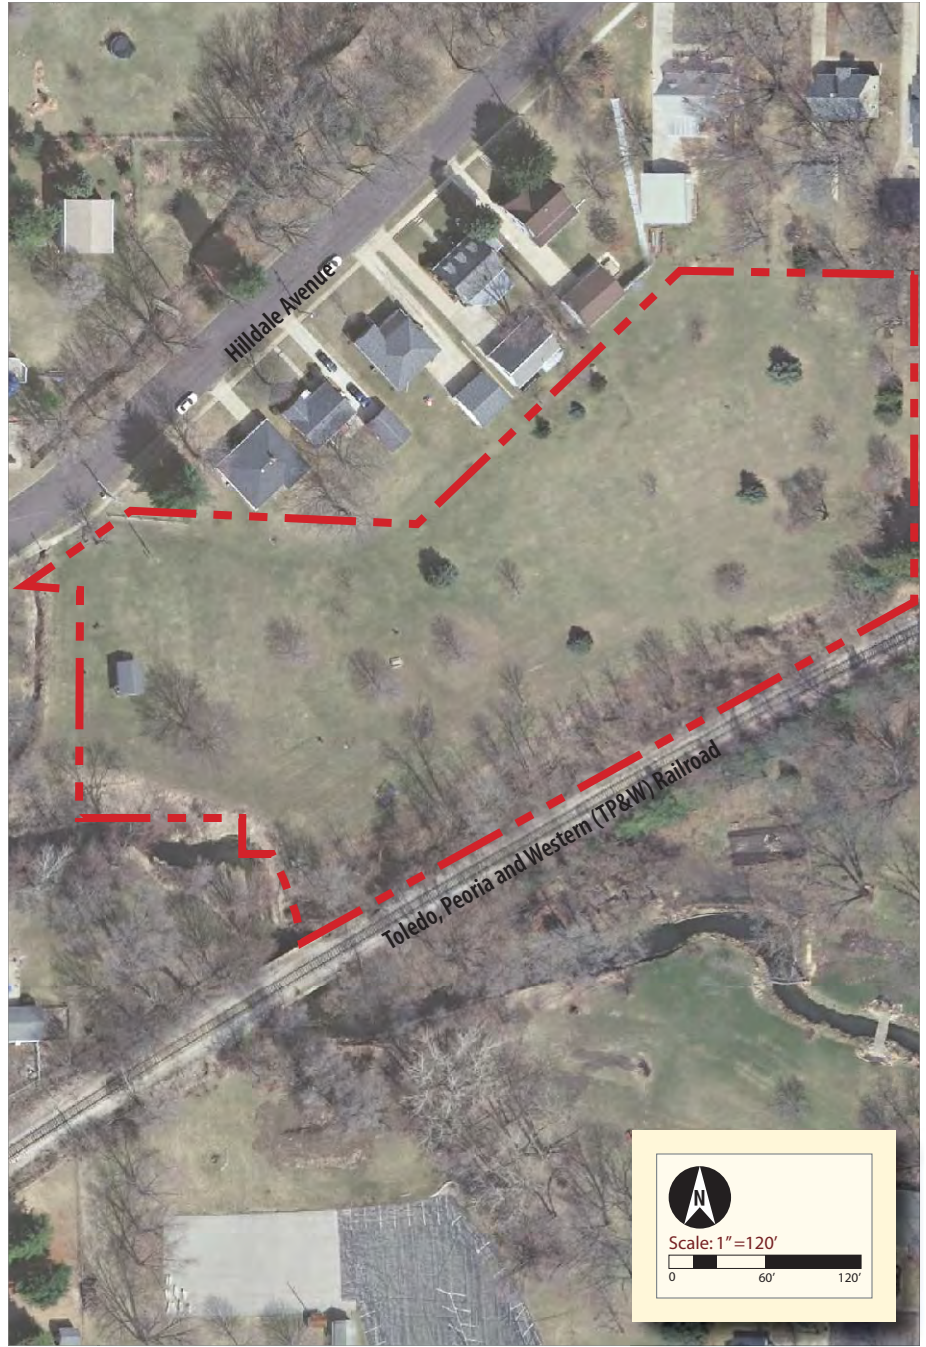
Aerial Photo of Sweitzer Park
